# **City of Arcata**

## **Old Arcata Road Proposed Project**

## **Wetland Delineation Report**

Version 2. July 2021  
(Version 1: January 2019)

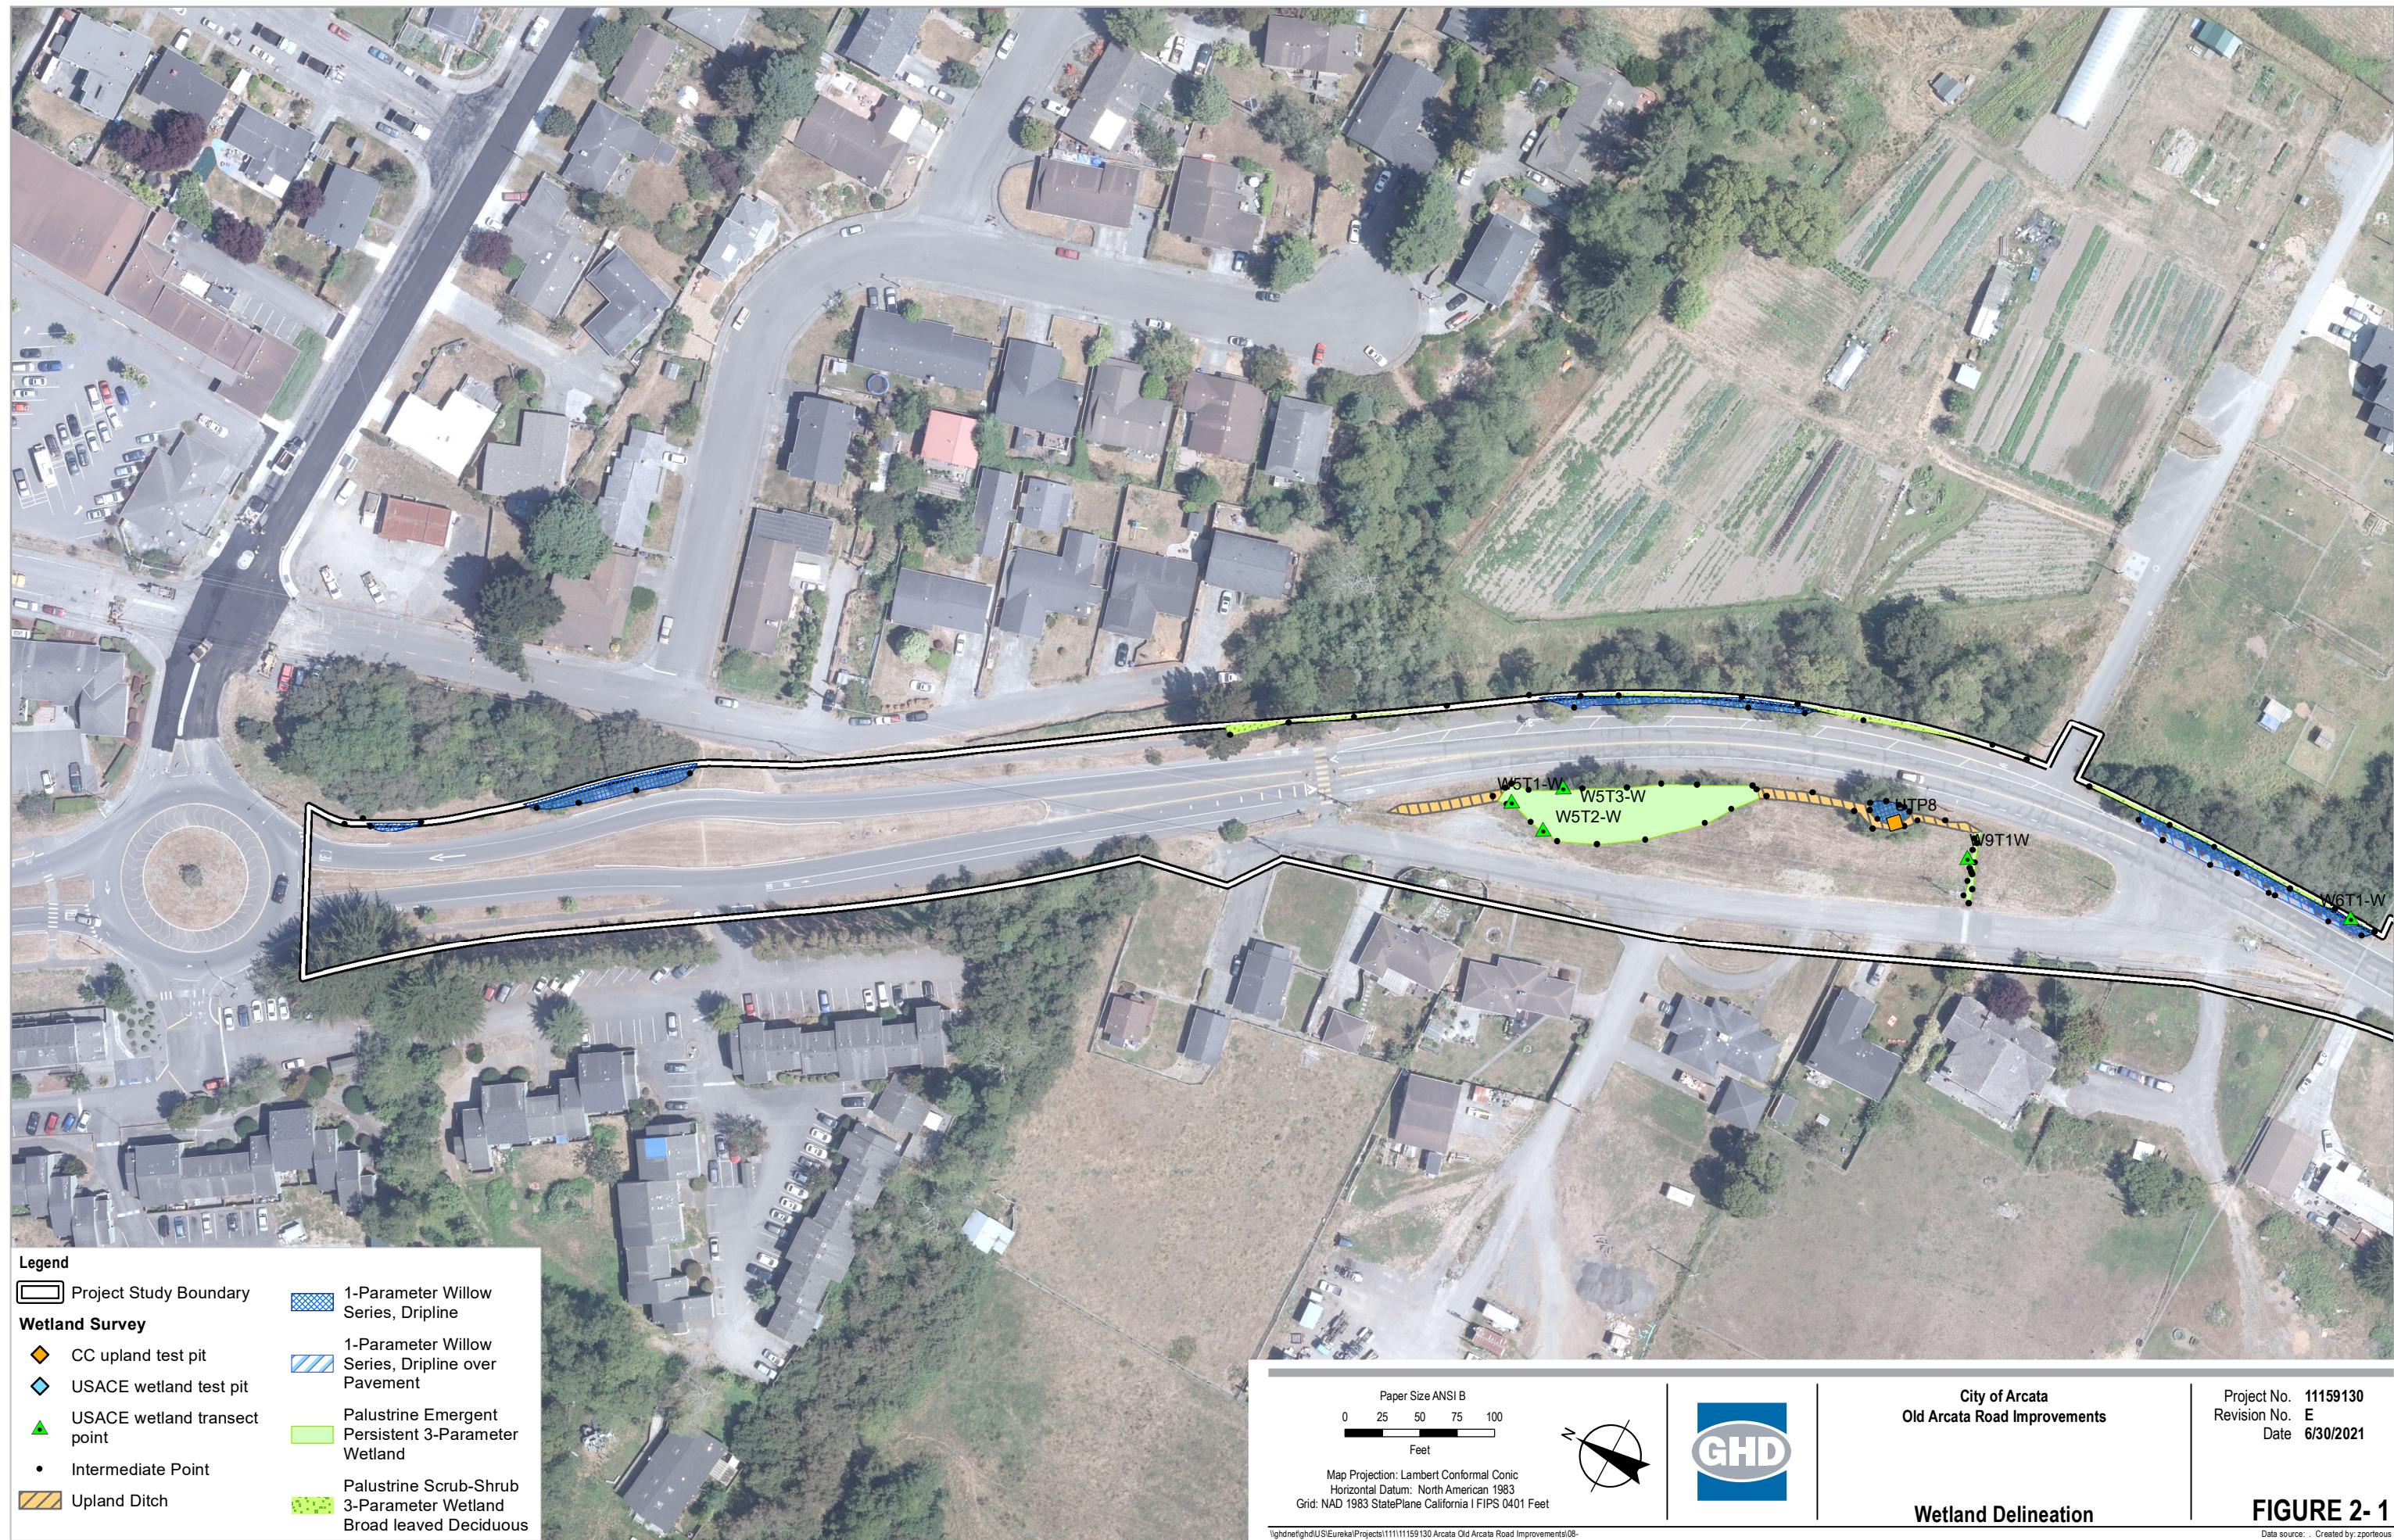
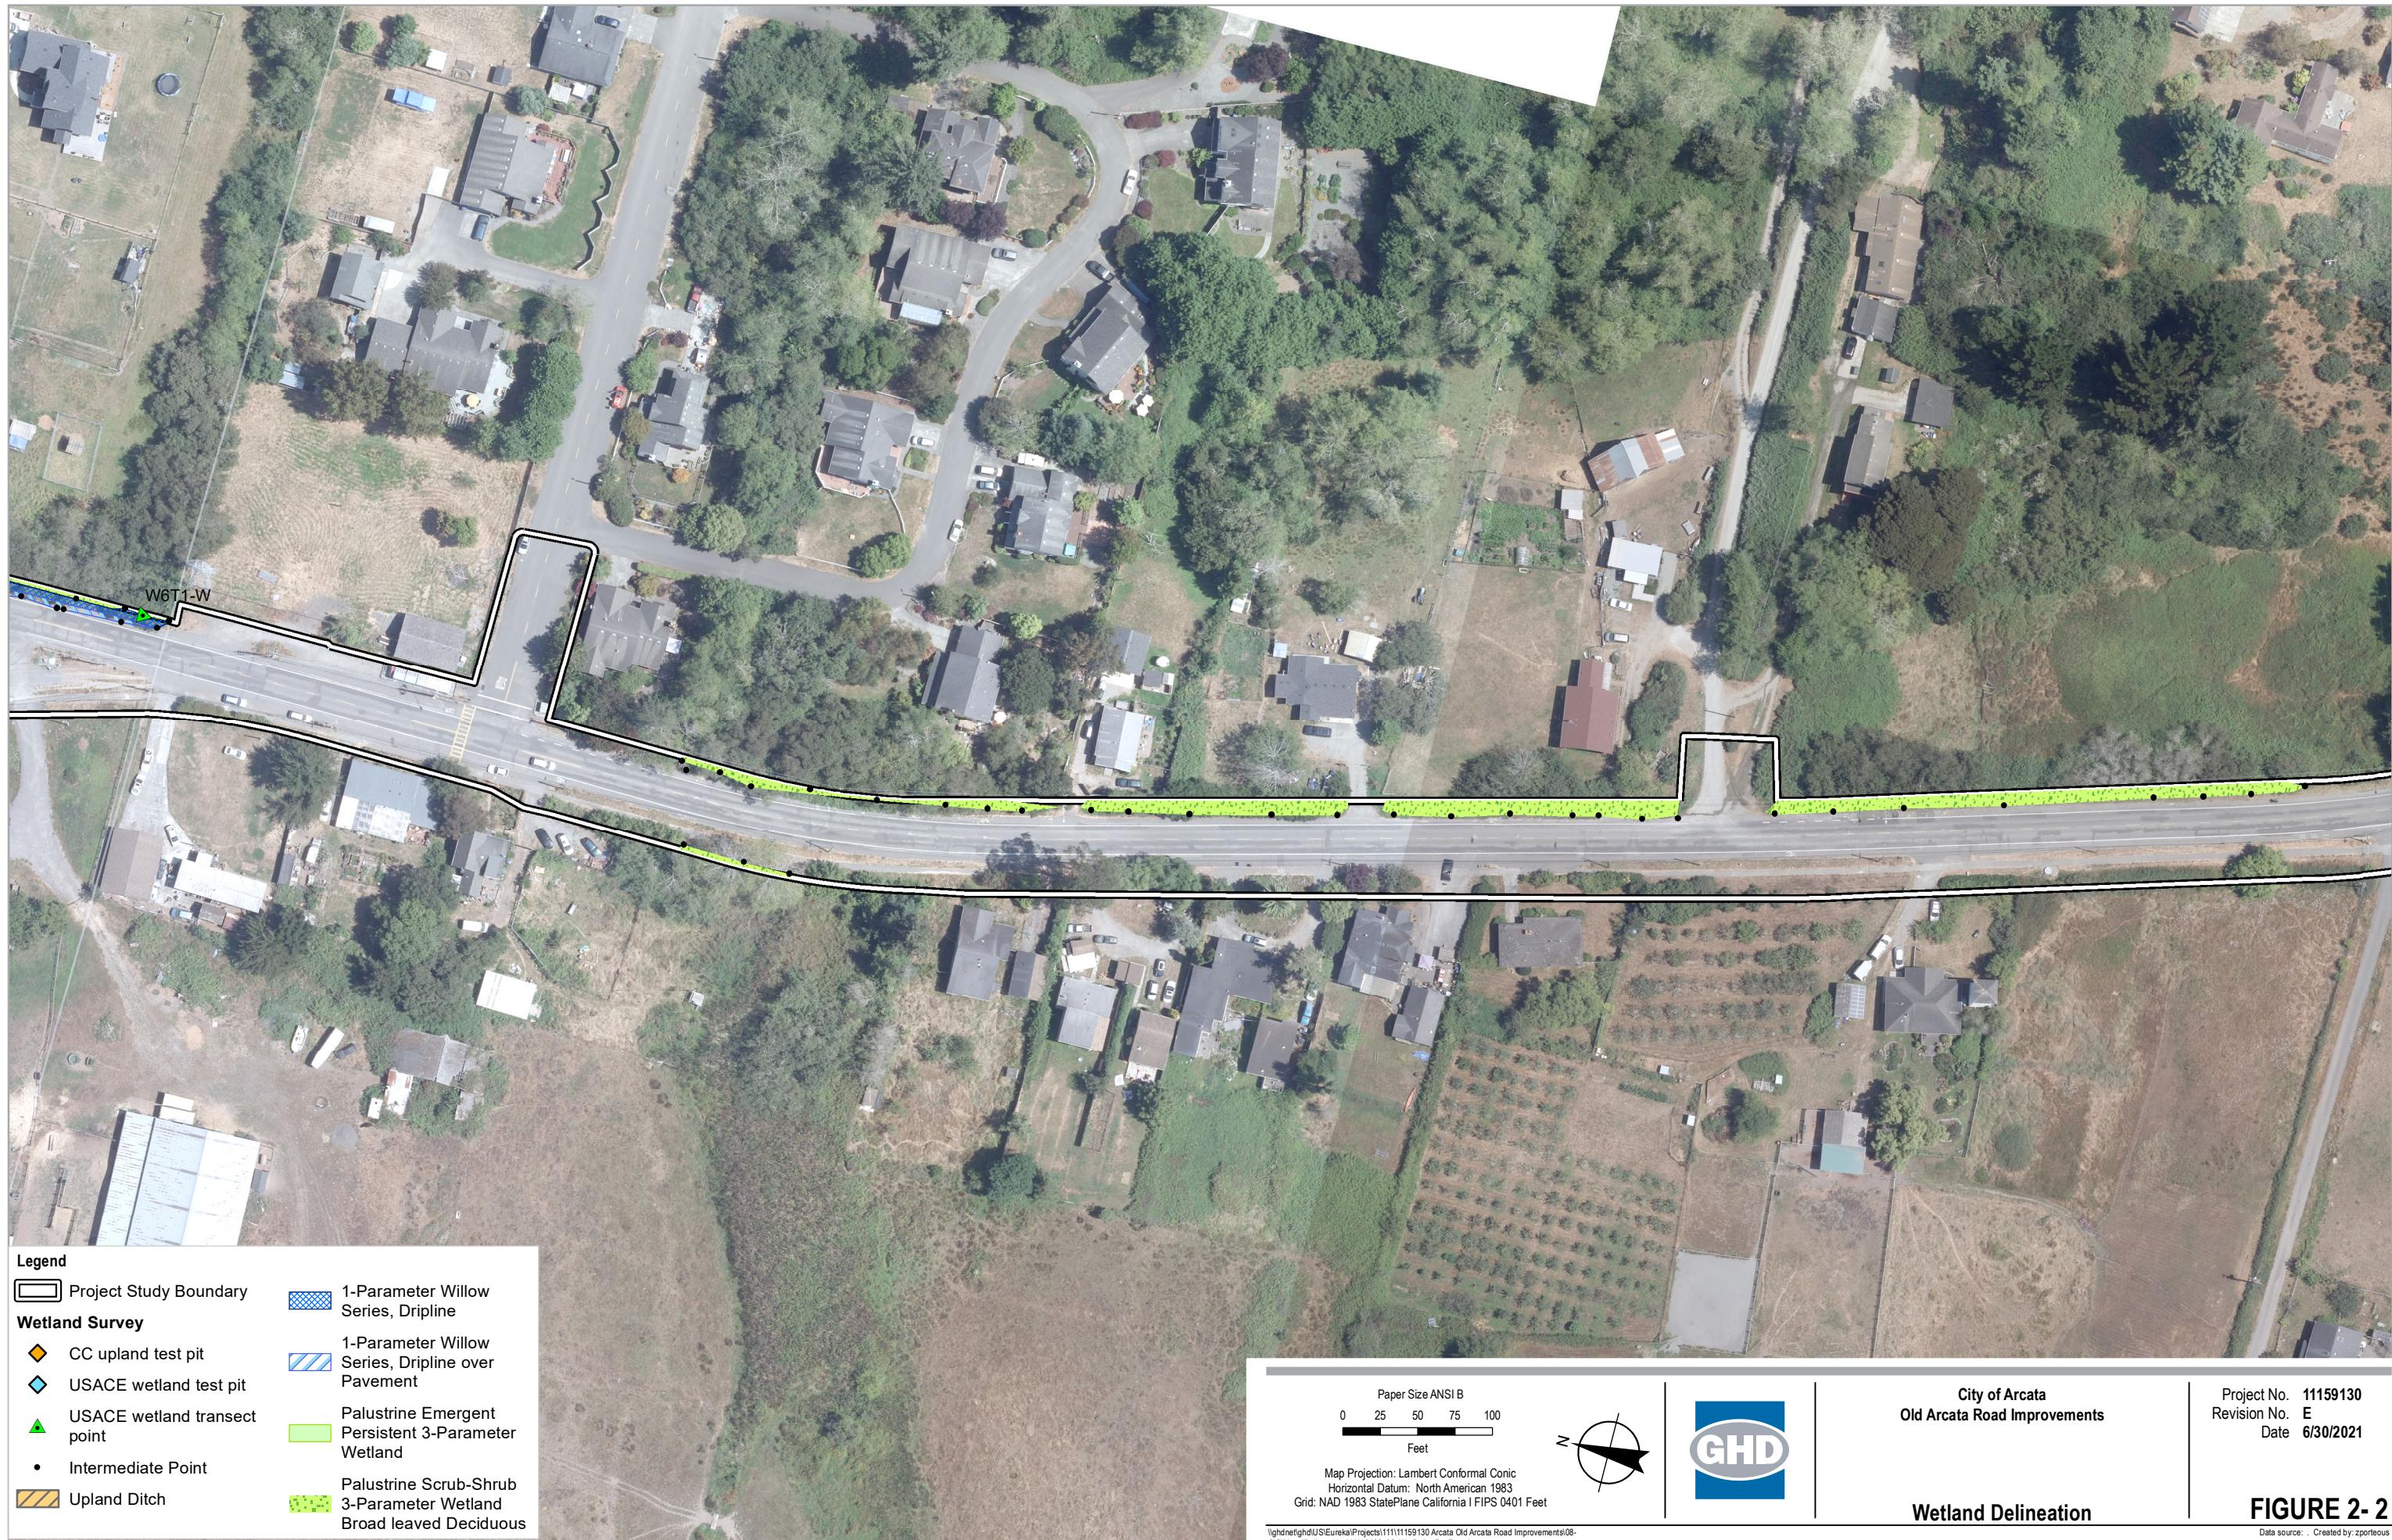
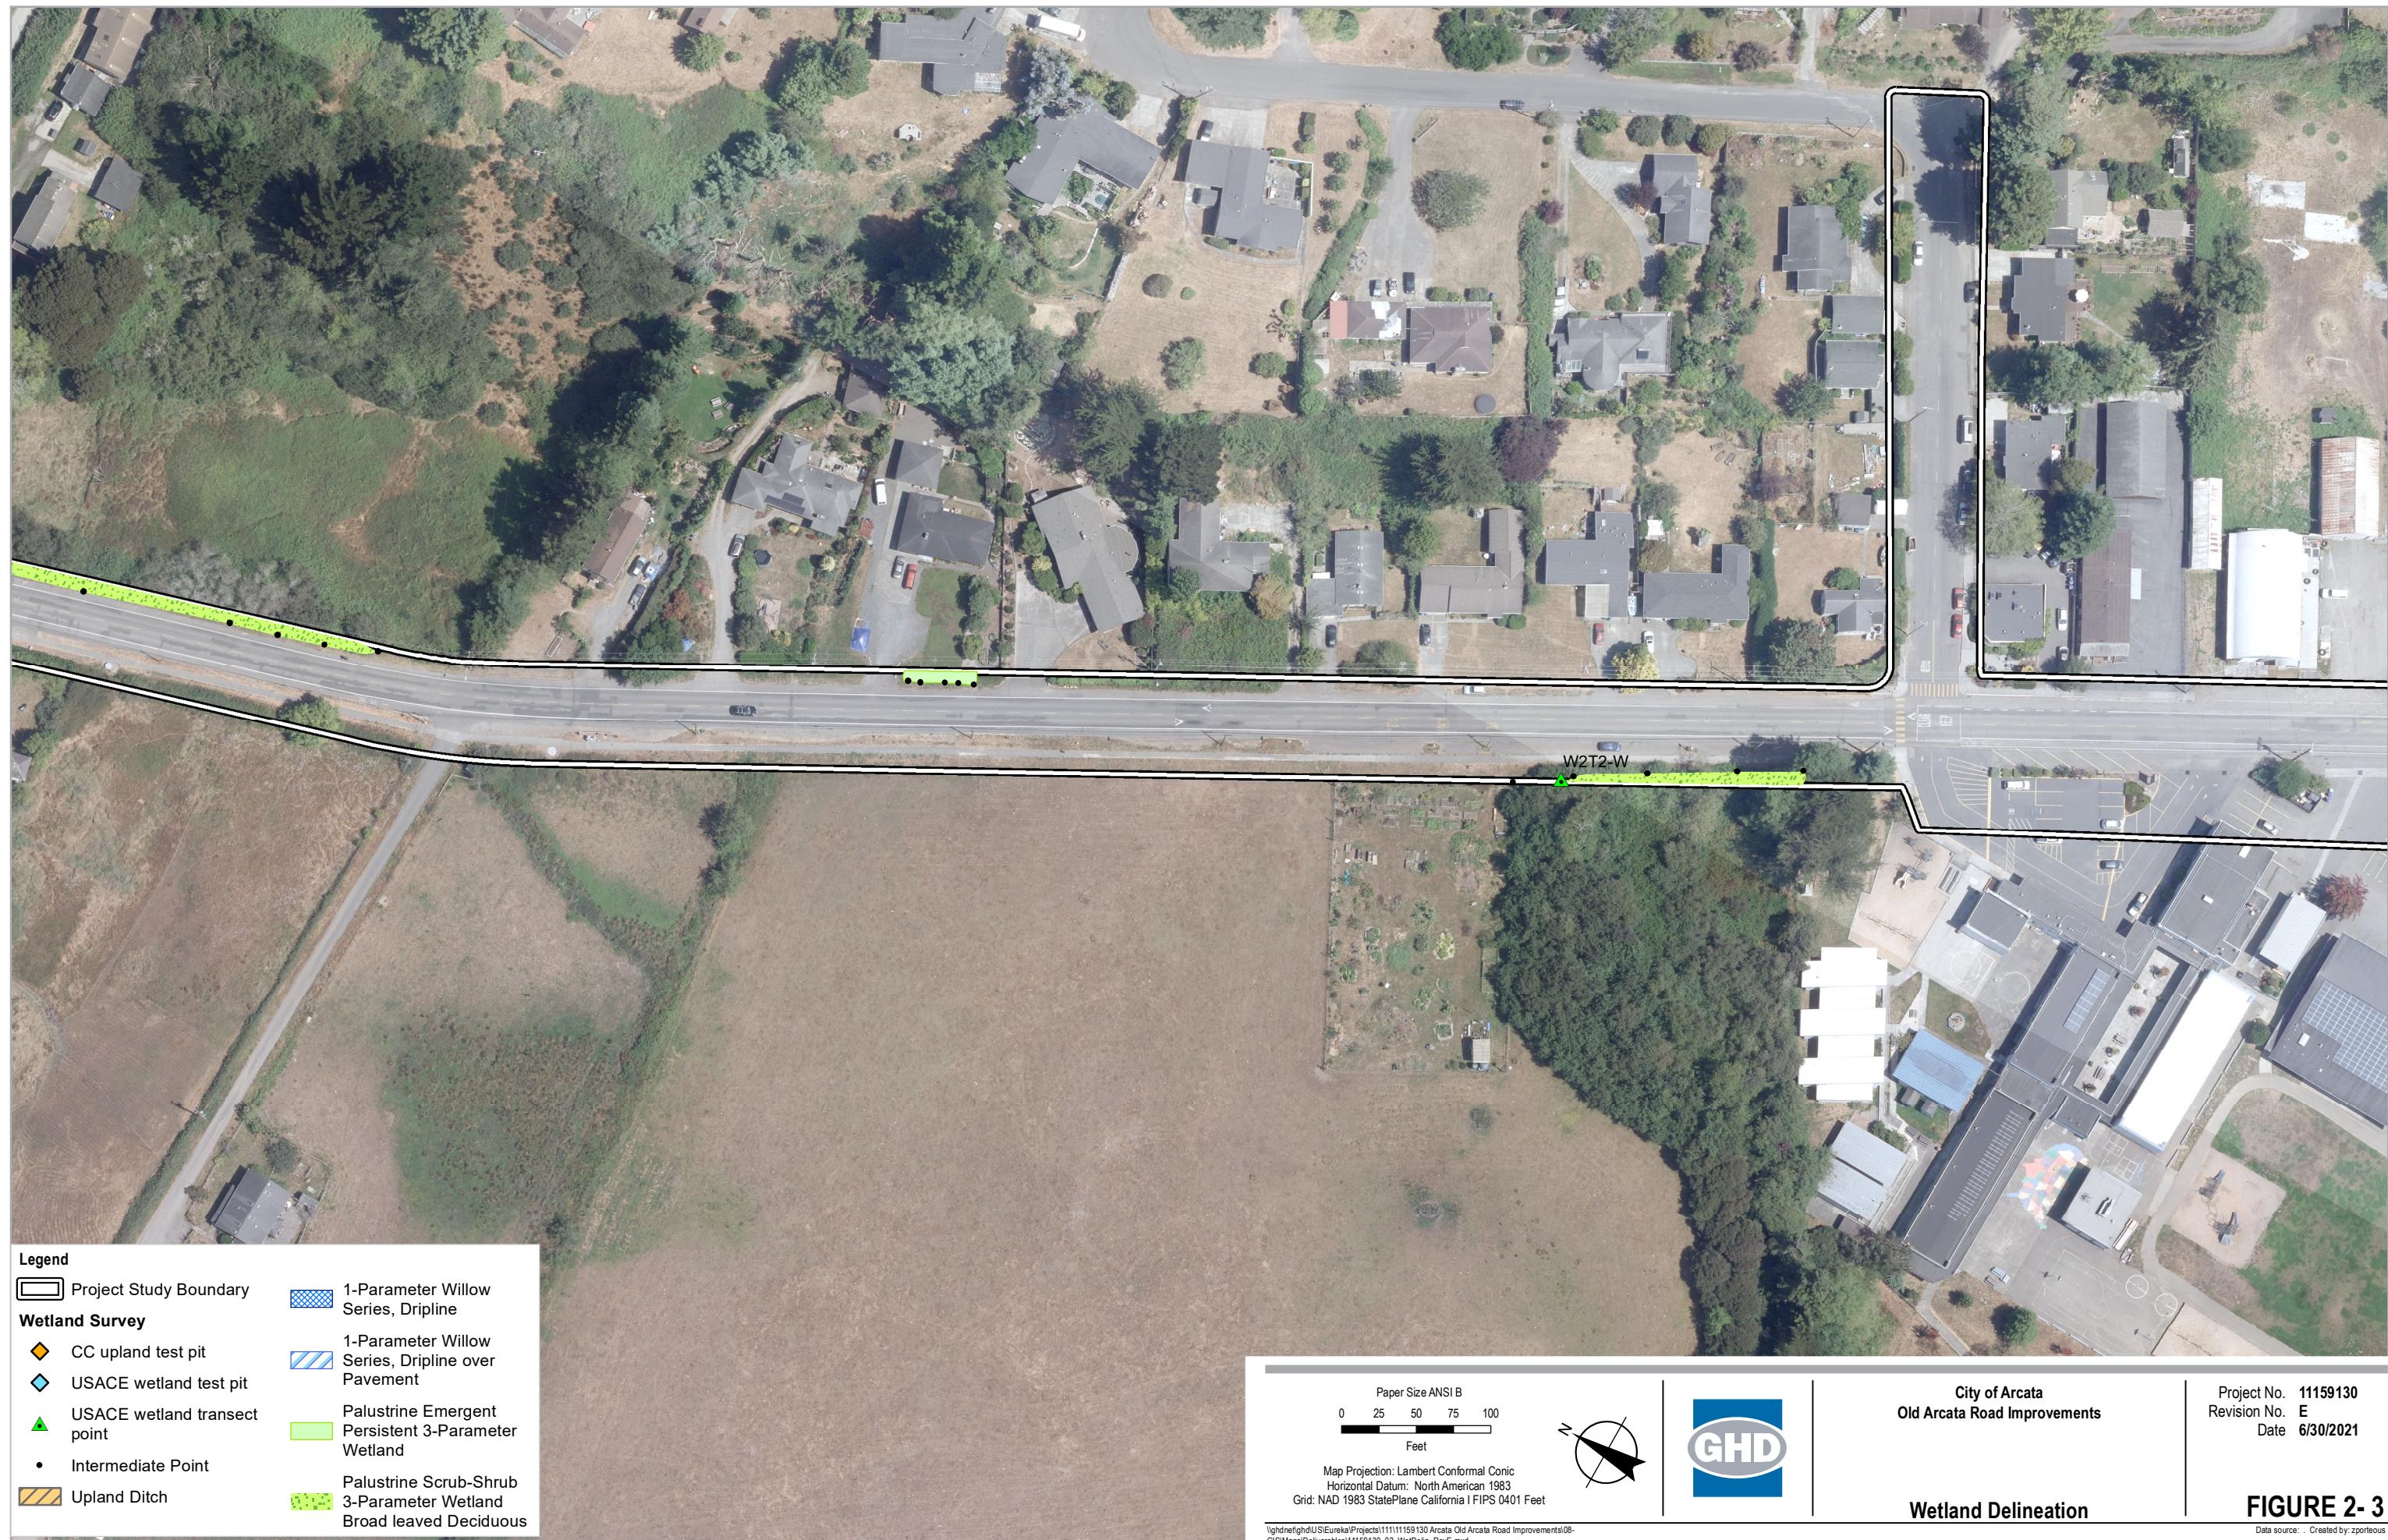
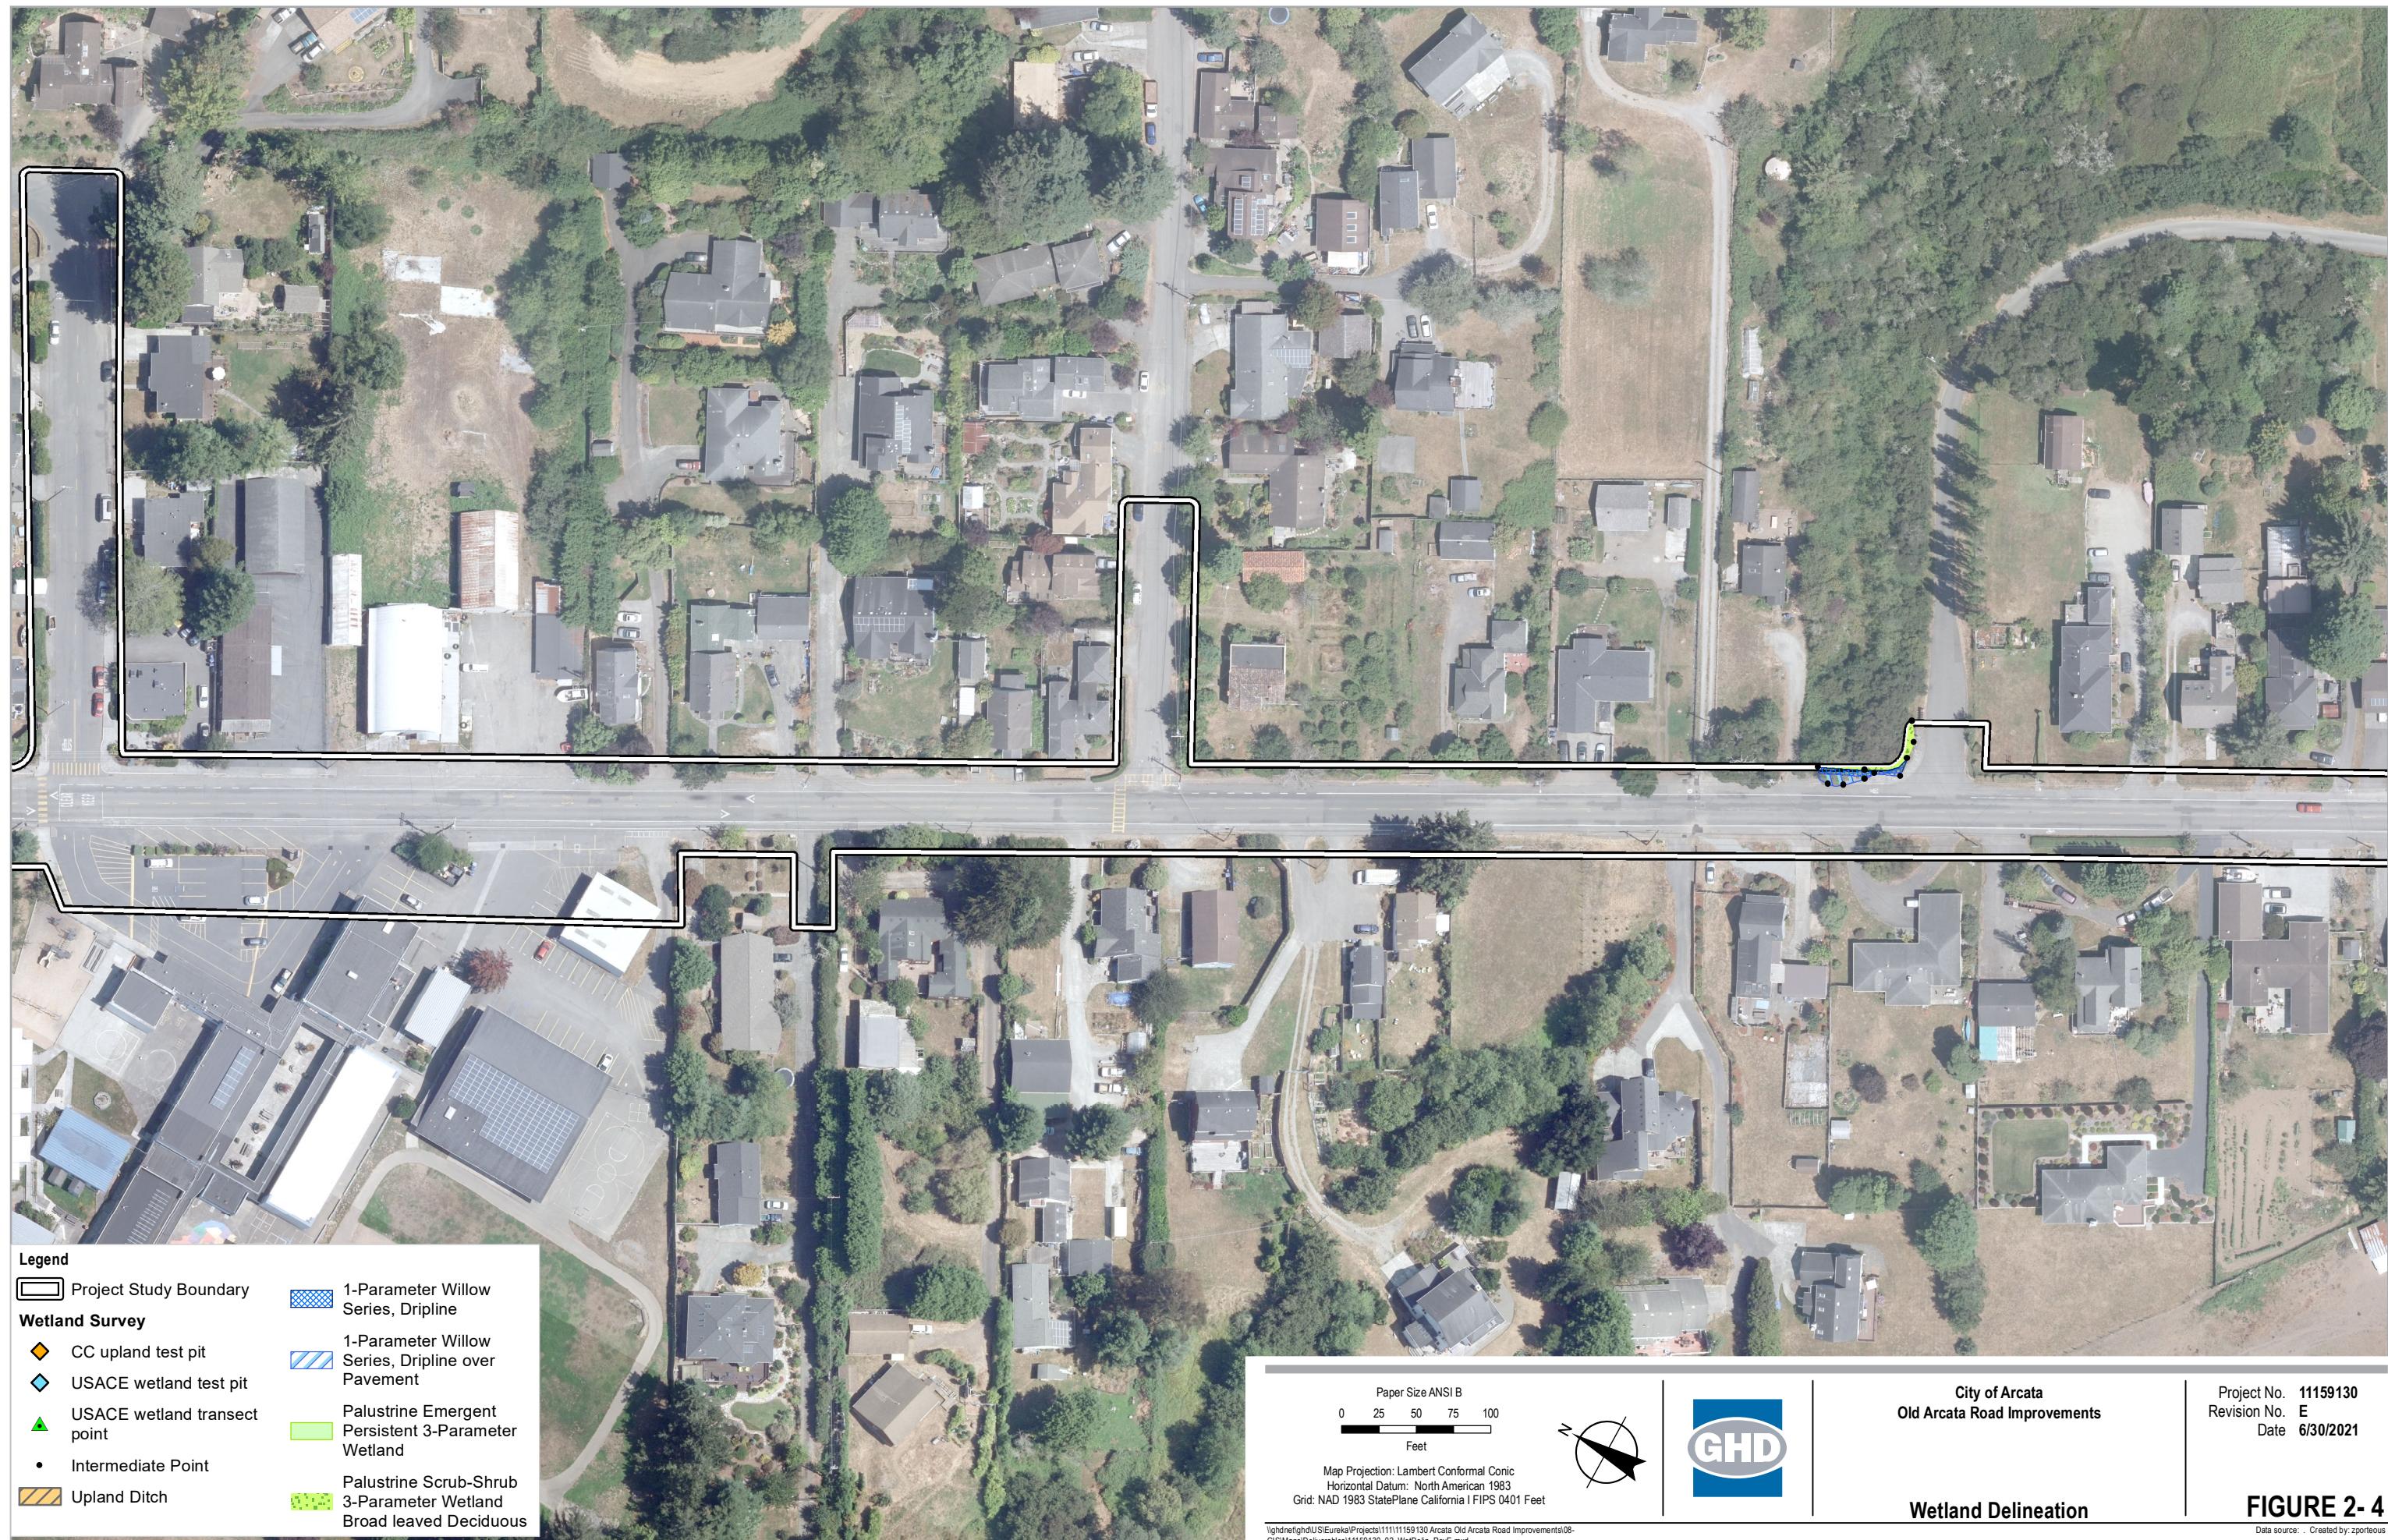
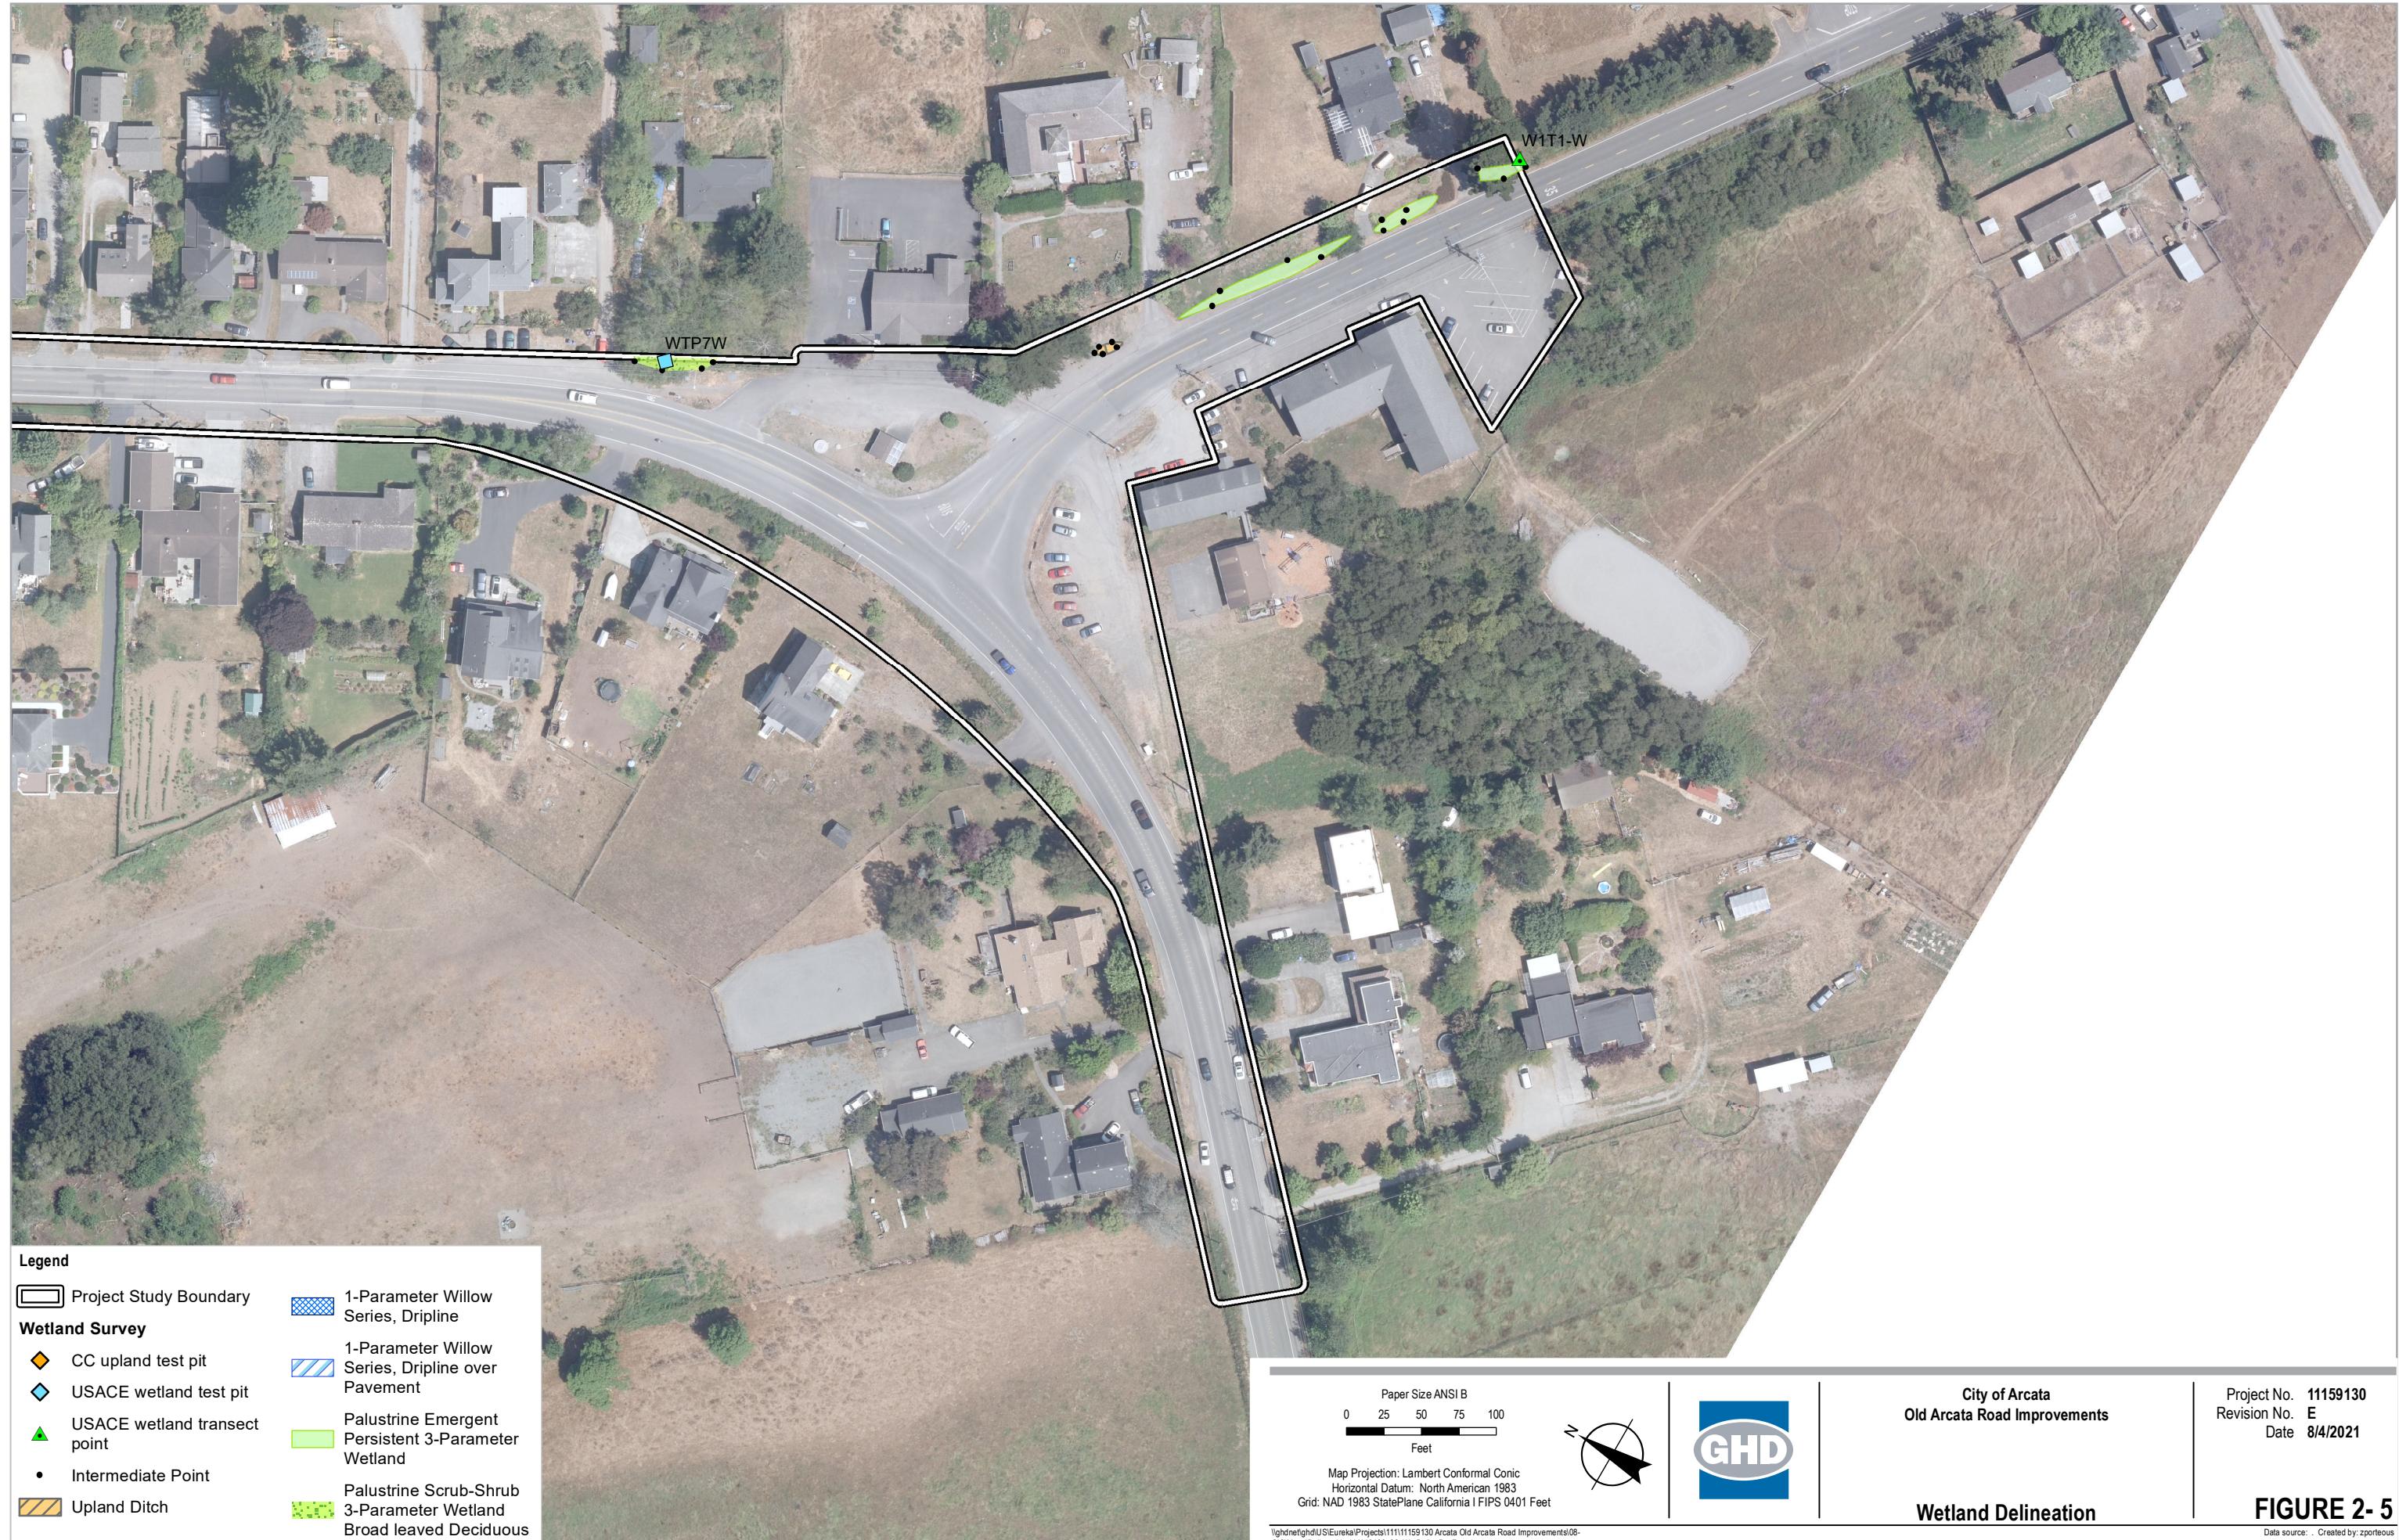
Intermediate GPS points were collected without the collection of data (soils, vegetation, or hydrology) as appropriate, and are shown without labels on the figures. In addition to the paired transect plots, one wetland test pit and one upland test pit were described that were not part of paired transects. These were labeled “WTP7” or “UTP8” respectively. In the case of the wetland test pit “WTP7”, a paired upland test pit was not dug due to the presence of underground utilities. The upland test pit “UTP8” was completed to confirm the presence of 1-parameter wetland based of vegetation, and the lack of soil and hydrology indicators.

During the delineation mapping, each section of wetland was designated with a number e.g. “W1”. Wetland transects were labeled with a respective wetland number. Some wetland sections were mapped from intermediate points only, with no transects completed for these sections. For this reason, two wetland identification numbers are missing from the sequence of the transect datasheets (3 and 4). In addition, GHD revisited the road median on the northeast side of the PSB, which is why it contains non-sequential transects. All data collected during the delineation is included in Appendix B.

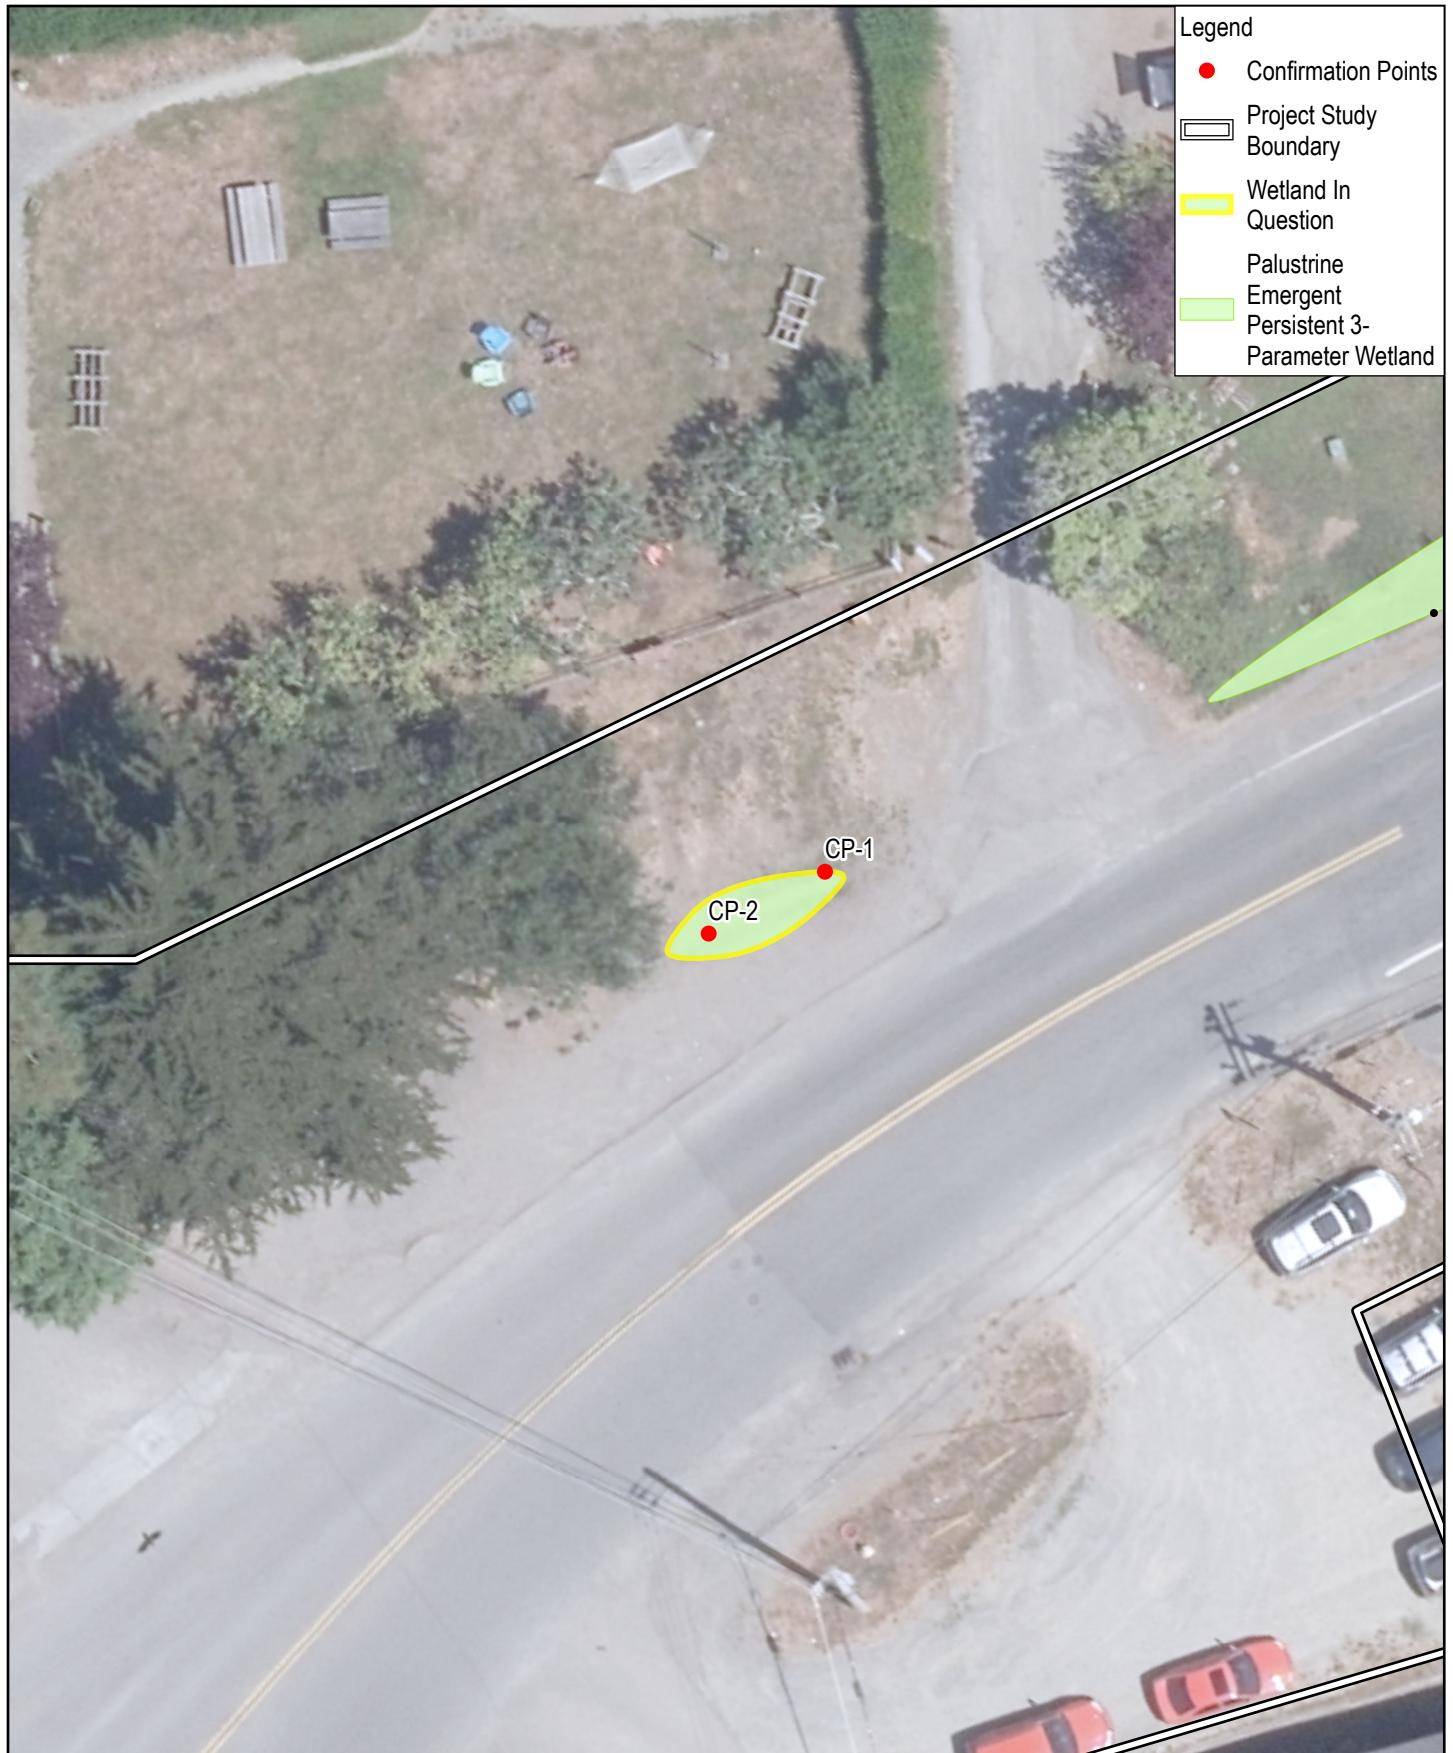
**Figure**

Two GHD wetland scientists visited the area in question on June 23, 2021 and dug two pits to collect vegetation, soils and hydrology data. The two pits are labelled CP-1 and CP-2, ("Confirmation Point"), on the attached Figure 1. Conditions at both CP-1 and CP-2 do not meet all three parameters to be considered a USACE-jurisdictional wetland resource under the Clean Water Act. Datasheets for CP-1 and CP-2 are attached to this Technical Memo as Attachment 2.

- Soils at both sites contained very gravelly sandy loams, and which consisted of river run fill material in the upper horizon.
- CP-1 contained potentially hydric soils due to the chroma of 3 and low value (< 2), and presence of redoximorphic conditions in the lower horizon (9.5-13 inches). However, the lower horizon started at a depth greater than 8 inches to the surface, and is therefore not meeting any hydric soils indicators per the USDA/NRCS 2018 Hydric Soils Indicator Guide.
- CP-2 contained soils with low chromas (< 2), and low value (< 2), however did not contain any redoximorphic features or other indicators (such as odors) of hydric soil conditions.

- No surface water was present at both CP-1 and CP-2, however this area is known to seasonally pool during the wet winter months as it is located between a culvert and storm drain.
- No primary indicators were observed at CP-1 and CP-2, however one secondary indicator (Geomorphic Position) was observed at both sites.
